Application Note

Case story - Early detection of wind turbine faults using remote monitoring

Four case studies demonstrate how an effective remote condition monitoring strategy avoids costly downtime and consequential damage.

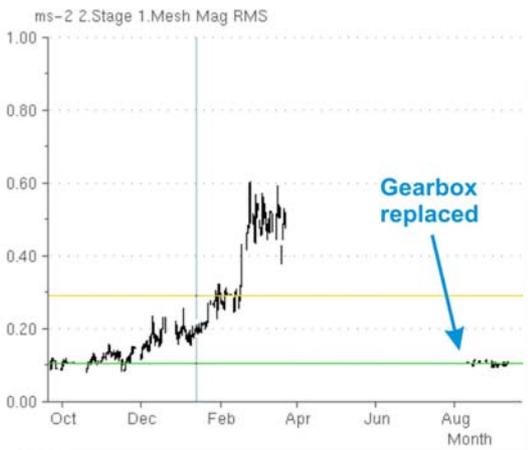
Figure 2. Gear mesh frequency trend of second-stage gearbox.

Gearbox second stage gear mesh frequency (first order) exceeds the Alert alarm limit.

Fig. 4 shows the metal shavings in the oil filter coming from the damaged second stage of the gearbox. A new gearbox was installed. The damaged gearbox required minimal repair since a catastrophic failure was avoided. The trend plot in Fig. 2 shows the gear mesh frequency trend before and after servicing the gearbox.

The gearbox should be visually examined when convenient, paying particular attention to the second stage gear teeth condition. The gearbox mounting bolts and support structure should also be checked.

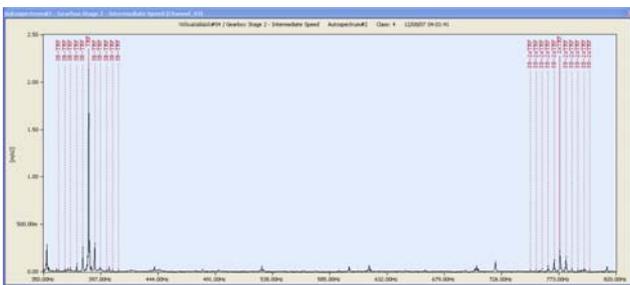
Figure 3. Envelope of second-stage gearbox.

Detailed analysis shows sidebands around the first and second order gear mesh frequencies of the gearbox second stage, which confirm a gearbox fault.

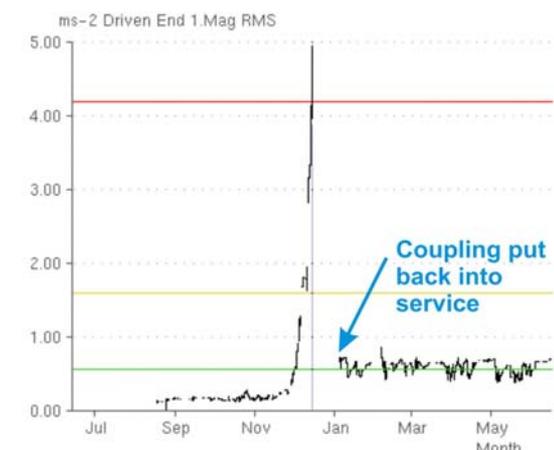
Figure 5. First order RMS trend of coupling.

Rapid rise in the first order RMS vibration magnitude exceeds Danger alarm limits. The other measurements indicate there was no rotor unbalance or bearing faults.

The rapid rise in generator driven end first order magnitude indicates a change in the stiffness of the bearing or the coupling, possibly due to loose holding down bolts or structural components.

Inspect generator rotor, bearing and coupling for possible loose components.

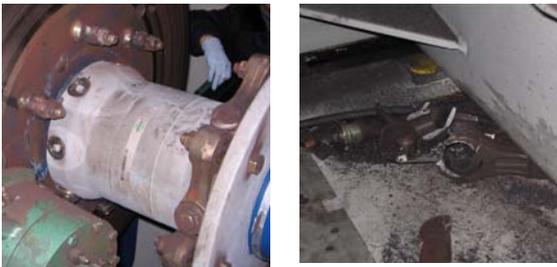
Figure 6. Sheared coupling links.

Fig. 6 shows the sheared coupling links. The trend plot in Fig. 5 shows the first order magnitude vibration trend both before and after servicing the coupling.

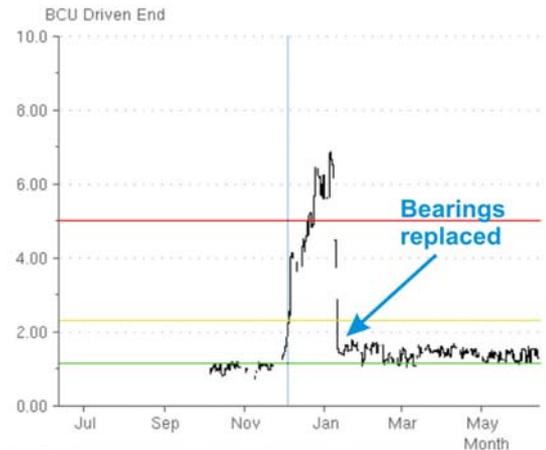
Figure 7. BCU trend at generator driver end.

Generator driver end BCU (Bearing Condition Unit) measurement exceeds Danger alarm limits.

Fig. 9 shows the damaged inner race. Fig. 7 shows the trend plot before and after replacing the bearings.

The bearing should be checked as soon as possible and replaced, if necessary.

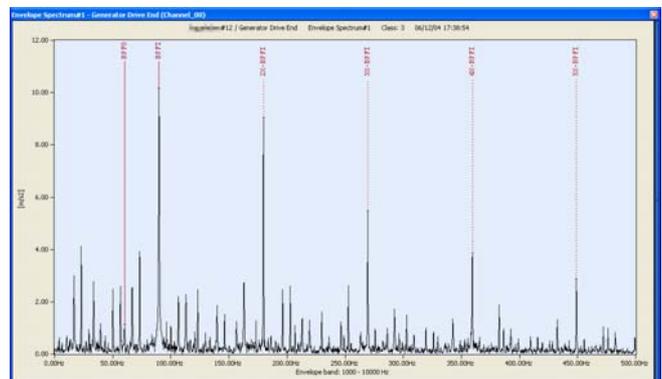
Figure 8. Envelope plot of generator end bearing.

Further analysis using envelope plot confirms an inner race bearing fault. This is typically characterized by a series of harmonics from the inner race bearing fault frequency (BPF1).

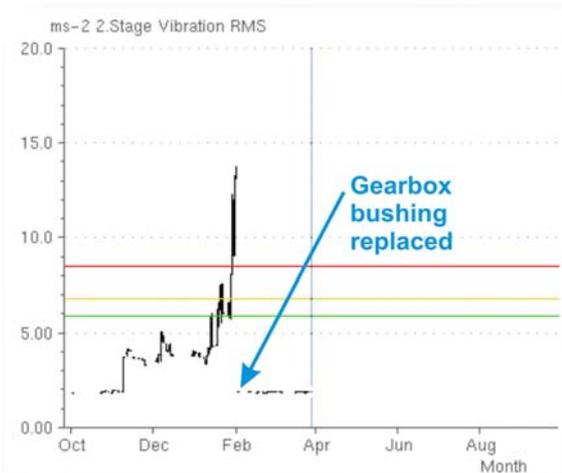
Figure 10. Overall vibration trend of second stage gearbox.

Rapid rise in second stage gearbox overall vibration level to above Danger level in power bin 5 (>1200kW). progressive rise but below Alert level in power class 4.

The other measurements indicated there was no problem in the gears themselves.

The rapid progressive rise in the second stage gearbox overall vibration level indicates a deterioration in the condition of, or looseness, in the gearbox support pads or structure. Because it occurs only at the highest active power bin, there could be a possible structural resonance resulting from a reduced structural stiffness due to looseness of the support structure.

The gearbox should be inspected immediately for mounting or looseness problems. It should also be visually inspected internally for possible contacting rotating parts.

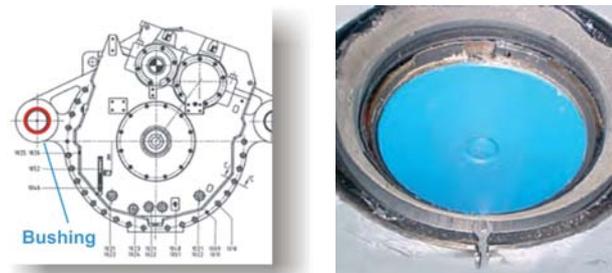
Figure 11. Gearbox support bracket.

Fig. 11 shows the cracked rubber bushing on the support bracket (drawing on the right shows the location of the bushing on the gearbox). Fig. 10 shows the trend plot both before and after exchanging the bushing.
