Application Note

Case story - Early detection of wind turbine faults using remote monitoring

Four case studies demonstrate how an effective remote condition monitoring strategy avoids costly downtime and consequential damage.

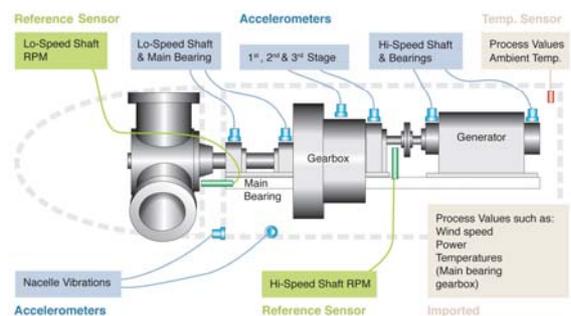
Figure 1. Sensor types and locations on a typical wind turbine generating unit train.

The critical areas to monitor on a wind turbine are shown in Figure 1.
